# Manhole Inspection Summary

Manhole # S23K\_\_015MH

Insp Date: **6/11/08 7:27 AM**

**Location** Address: **351 S Mount St**

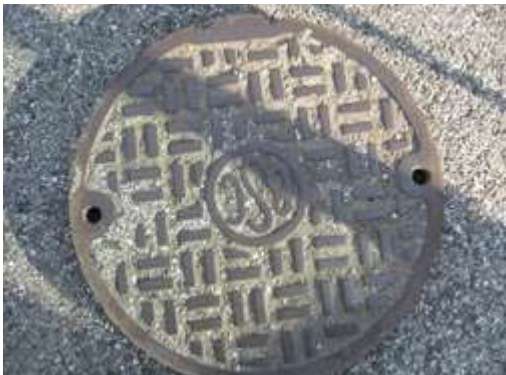
Cover View

Condition: **Worn**

Condition: ☐ Sound ☐ Cracked ☒ **Leaks**

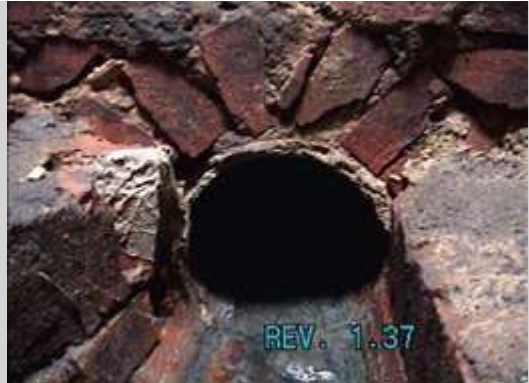
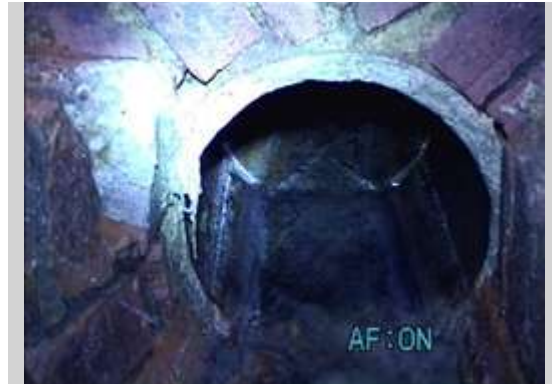
12 O'Clock Outflow

8 in. Circular Gravity Sewer  
Pipe Out @ 12 O'Clock

Pipe Height: **8.4** (in.) Rod and Bar (Angled)  
Pipe Material: **Clay** ☐ Pipe Lined  
Invert Depth: **9.20** (ft.) Flow Characteristics: **Fast**  
Deposits: ☒ None ☐ Mud ☐ Sludge ☐ Debris ☐ Grease  
Silt Depth: **0** (in.) Deposits Extent:  
Infiltration: **None** Pipe Seal Cond: **Sound**

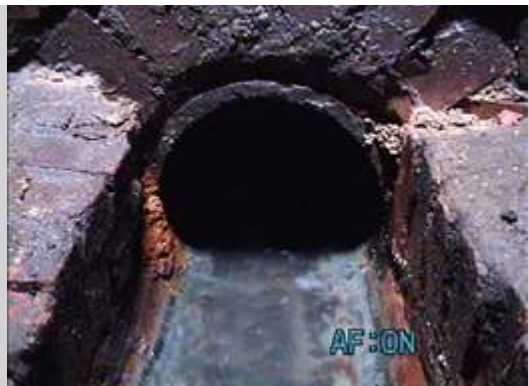
6 O'Clock Inflow

8 in. Circular Gravity Sewer  
Pipe In @ 6 O'Clock

Pipe Height: **8.4** (in.) Rod and Bar (Angled)  
Pipe Material: **Clay** ☐ Pipe Lined  
Invert Depth: **9.21** (ft.) Flow Characteristics: **Fast**  
Deposits: ☒ None ☐ Mud ☐ Sludge ☐ Debris ☐ Grease  
Silt Depth: **0** (in.) Deposits Extent:  
Infiltration: **None** Pipe Seal Cond: **Sound**
